CIRSCO Has Your Metal Roof Solution!

CIRSCO Has Your Solution!

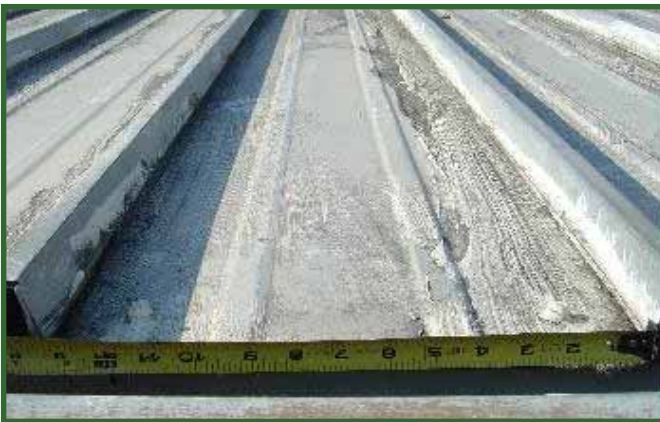
All fastener issues and rust must be treated

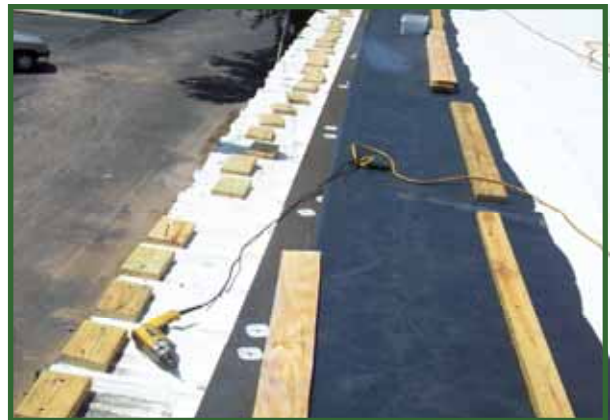
New treated wood nailers are installed around the complete perimeter of each roof area.

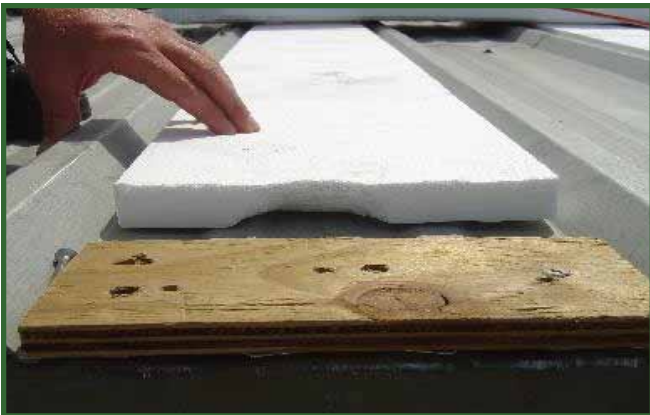
"Flute-filler" insulation is installed between the rib sections of the metal panels

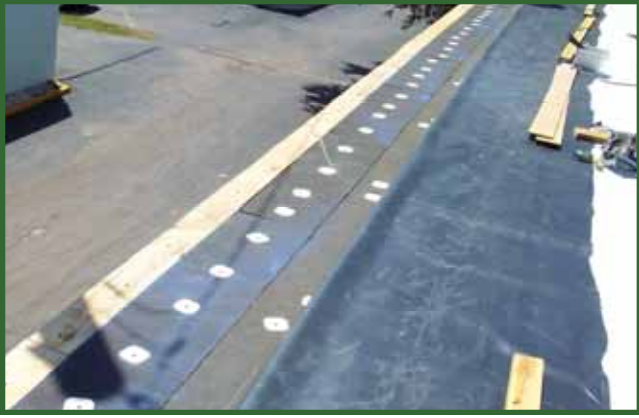
The treated wood is attached to the structural components to serve as anchors for the finished metal.

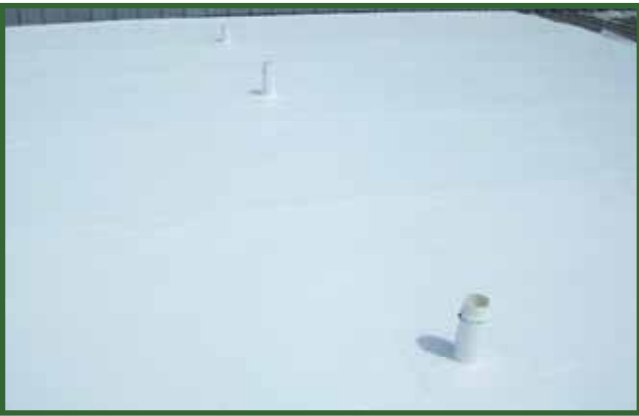
All roof penetrations are “flushed” with the same material heat-welded to the membrane.

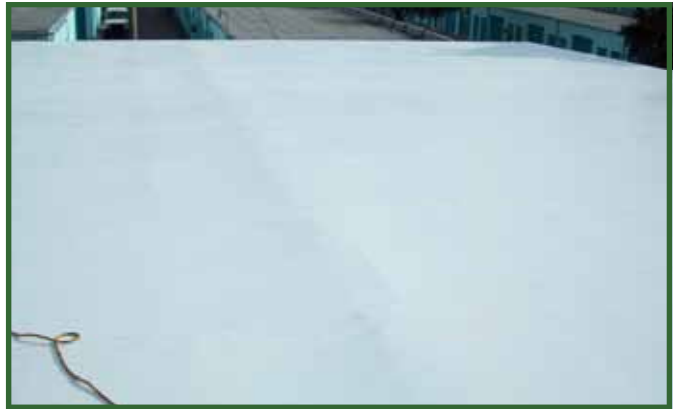
The finished roof is a durable, white, heat reflective, energy-star rated system with CIRSCO's 2-year warranty.

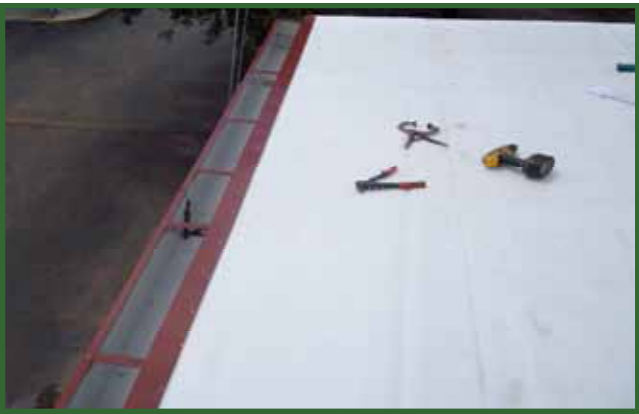
New pre-painted metal gutters are attached to the wood.

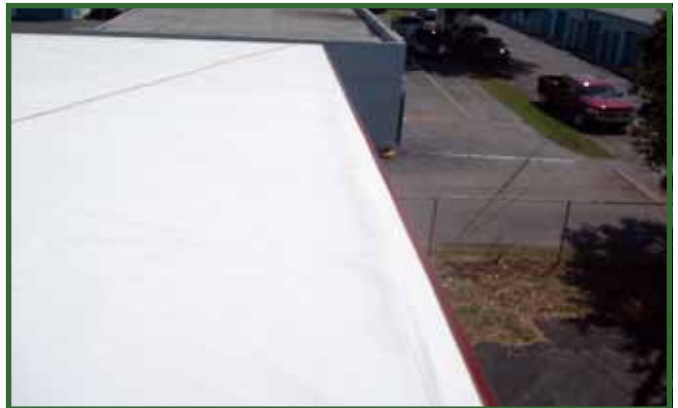
New edge metal is installed to complete the system.
